ULTRASONIC OR TEV?

By Greg Linton, HV Diagnostic Services Ltd

What is the difference and why do we use both Ultrasonic and TEV when locating Partial Discharge? This article will serve to explain the differences between the two methods in widest use round the world today.

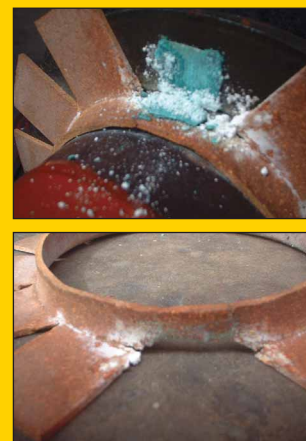
Figure 1

A routine substation survey in August 2004 located a discharge of 20% FSD from the breather of a CT chamber. This activity, originally measured at 12% in 2002, was definitely on the increase and the deterioration is typically exponential-like as the discharge gains momentum. The TEV readings quite rightly appeared normal and were unchanged from previous surveys. An inspection under a scheduled outage discovered discharge surrounding an earthing shim between layers of gasket material of the CT (see figure 1). The faulty component was replaced and a subsequent re-test has shown the installation free of any discharge activity.

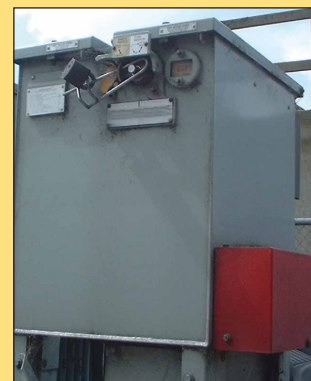
Figure 2

The annual visit to a Waikato Industrial site towards the end of 2004 revealed an unexpected increase in levels to one substation over the previous 12 months. The highest reading was recorded on the unused busbar end cap of an oil filled fuse switch (see figure 2). Although the background level was unchanged, indicating it was not external noise, the discharge was affecting all readings on the switchboard (see figure 3). The decision was made to replace the offending switch in a controlled manner prior to the beginning of their busy season. An investigation by the switch manufacturer confirmed that they found the likely source of the discharge around the teflon washers installed on the end of the buss connectors under the red cover identified. The substation was again surveyed in Feb 2005 with the readings returning to the levels previously recorded.
