NETWORK RELIABILITY

By Greg Linton, HV Diagnostic Services

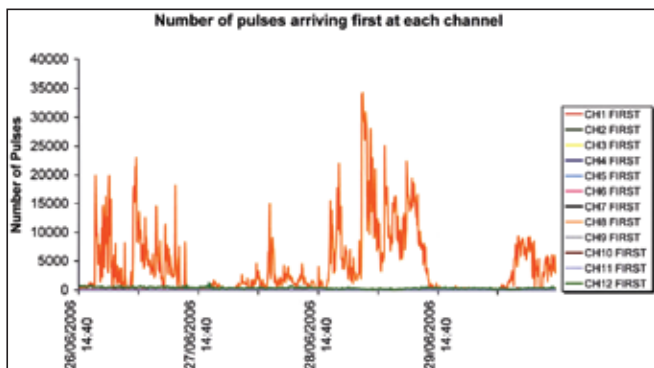
The work undertaken in 2006, commencing in June with a Location Survey, identified a return of previous Ultrasonic activity from the CT Chamber together with a further rise to Transient Earth Voltage levels. It was with great anticipation just days later that we installed one of our Partial Discharge Monitors for a period of continuous monitoring. These results confirmed a source of discharge activity from channel 8 positioned on the Switch Tank as illustrated in the following graph.

A consistent 28dB was recorded throughout the entire 4 days, which is right on the threshold for acceptable levels in Switch Tanks. The high number of pulses, peaking at 35,000 also suggested that further investigation was now necessary.

An outage to that feeder and subsequent inspection in October revealed two separate problems. First, the last remaining original CT was suffering from corrosion to the earthing shim. This is a known failure mode specific to this model and age switchgear and was not entirely unexpected. Second, the switch tank was opened and the oil changed. A loose turbulator and broken buffer washers were discovered internally and also corrected.
